WELDING INSPECTION REPORT

Resident Engineer: Casey, William **Report No:** WIR-027489 Address: 333 Burma Road **Date Inspected:** 20-Apr-2012

OSM Arrival Time: 700 **Project Name:** SAS Superstructure **OSM Departure Time:** 1530 **Prime Contractor:** American Bridge/Fluor Enterprises, a JV

Skyway Guard Rail:

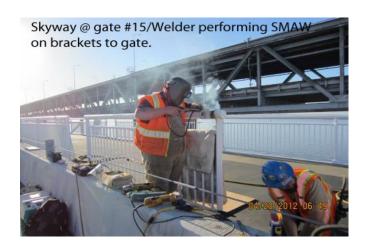
The QA Inspector at random intervals, observed ABF welder Jayson Collins (ID 8128) perform the Shielded Metal Arc Welding (SMAW) process in the 3G/4G vertical/overhead position on face "A" of the guard rail brackets at the East bound lane gate #13 as per change order #179. The welder was observed utilizing 3.2mm E7018-H4R electrodes obtained from a baking oven and drawing amperage of 130. QC Inspector was on hand to monitor the welding, parameters as they apply to ABF-WPS-D1.5-F1200A. On subsequent observations the welder was observed cleaning the work between passes by employing a small disc grinder, brushes and compressed air. The QA Inspector noted the welding at this location to be not completed at this time on this date when the QA Inspector departed from the work location.

Work performed appears to be in general compliance with contract documents.
